Price River Canal Drainage Assessment 2008

Carbon County GIS Dept.

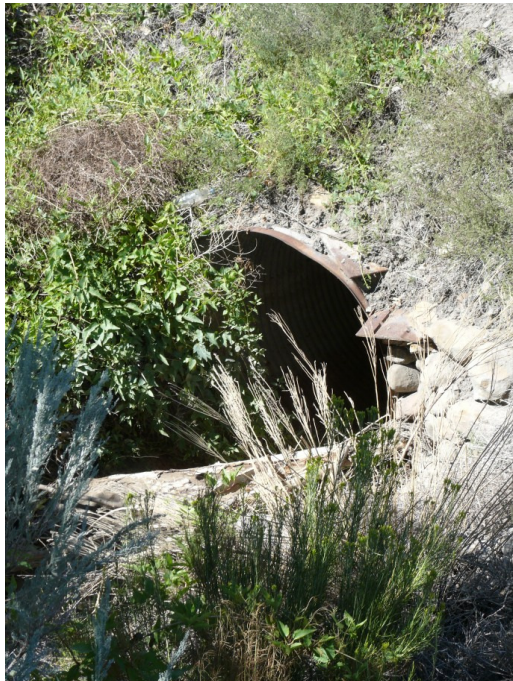
F.

Picture F shows where the water (heading west towards the river) crosses underneath the railroad tracks that parallel Spring Glen Road.

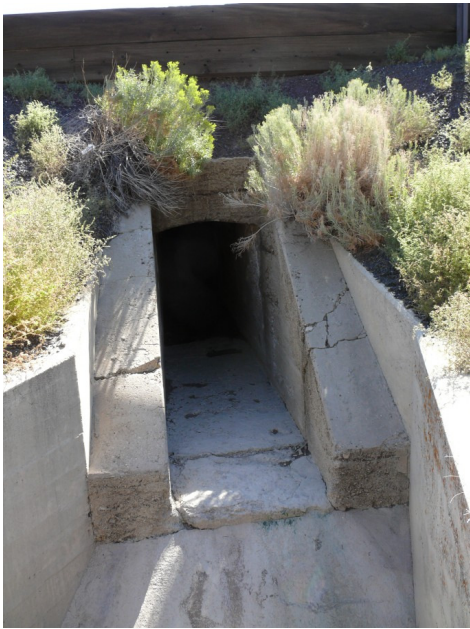
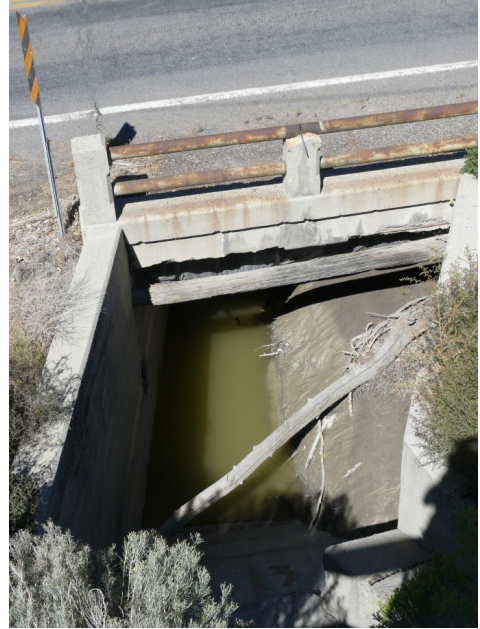
Pictures G & H are on the east side of the bridge traveling towards Helper. They show where the water enters underneath the road towards the Price River.

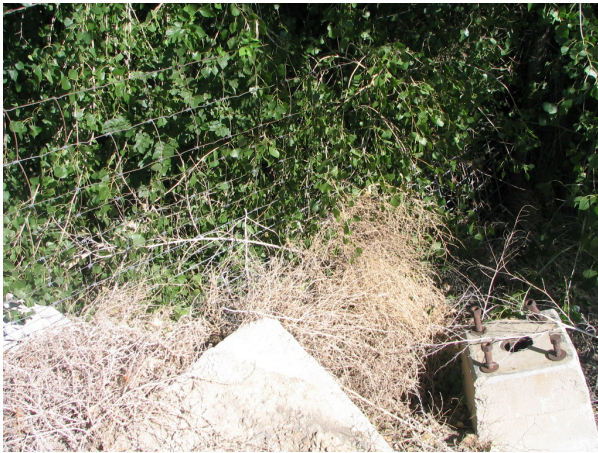
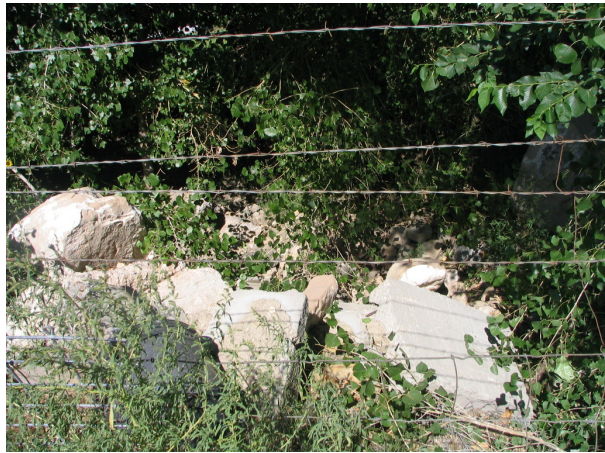
Pictures D & E show where the water crosses Matthew's fence and heads west towards the railroad tracks.

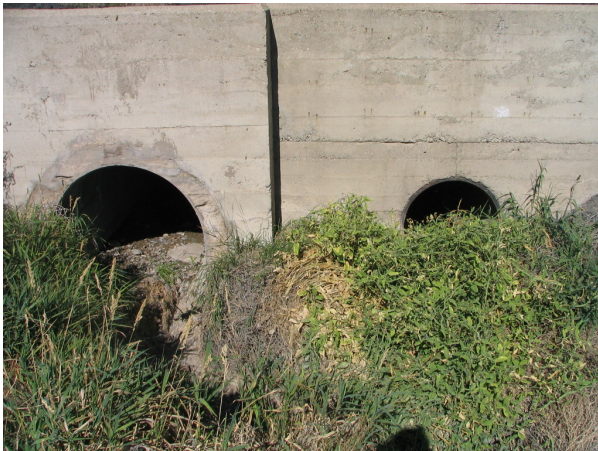
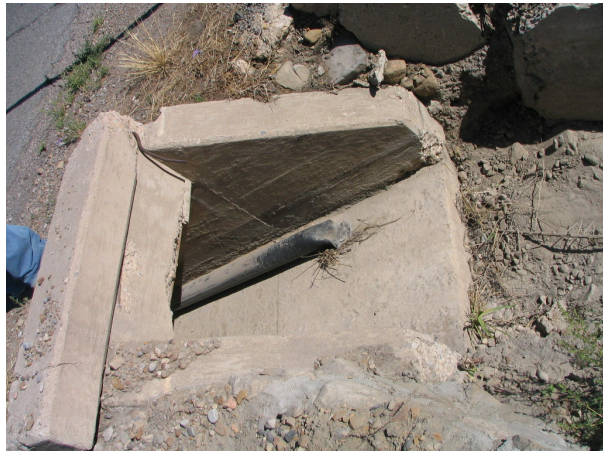
Pictures F & G show where the water comes out underneath the railroad tracks and road (heading west towards the Price River).

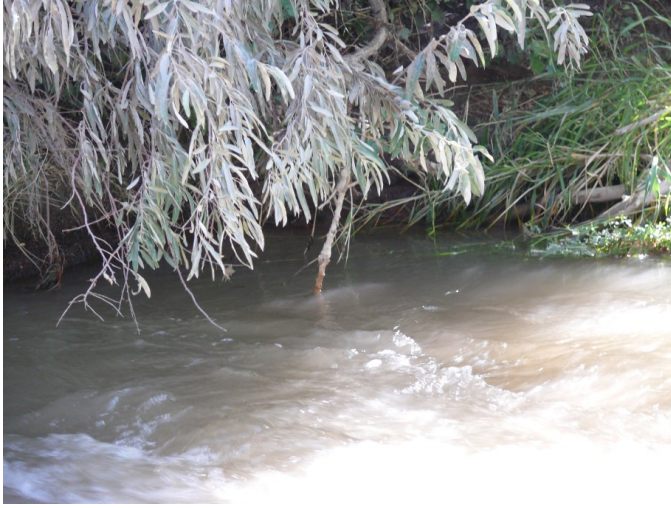
H.

Picture H shows where the canal runs into the Price River. It is behind the Honda shop on HWY 6.

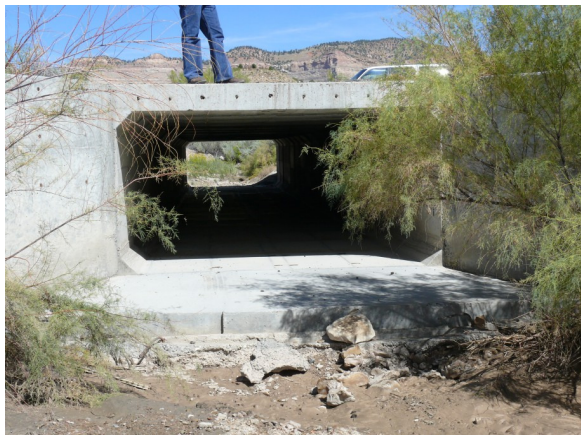
A.

Picture A shows where the water enters underneath the road.

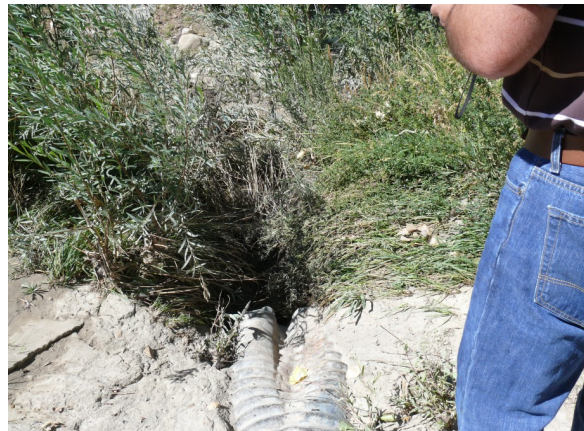
E.

Picture D shows where the water comes out of the drainage along the south side of the field and enters a pipe that goes under the private dirt road. Picture E shows where the water comes out of the pipe under the private dirt road and enters back into the drainage.

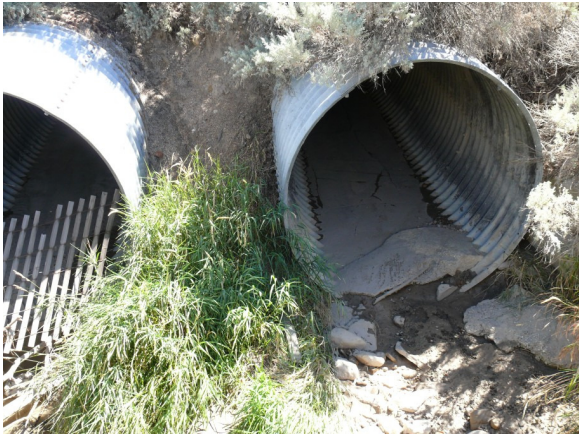
M.

Picture M shows where the water comes from underneath the railroad tracks and enters underneath Spring Glen Road. As you can see from the picture, a fence is attached to the culvert on the left. If water comes through this, debris may possibly cause blockage.

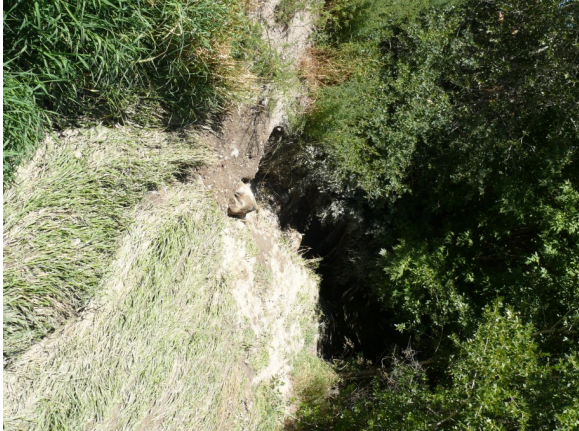
N.

Picture N shows where the water comes out underneath Spring Glen Road heading West towards the Price River.

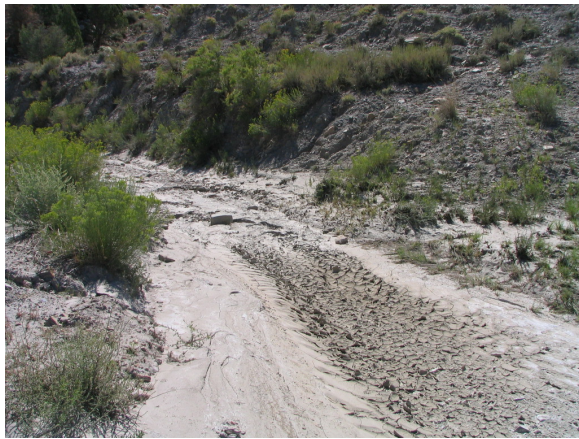
A.

Picture A shows where the wash heads west. Wash is by Ve'a's property.

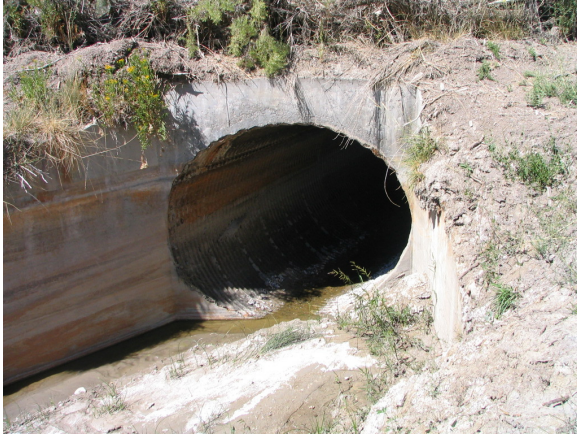
B.

culvert

Picture B shows where the wash goes into a

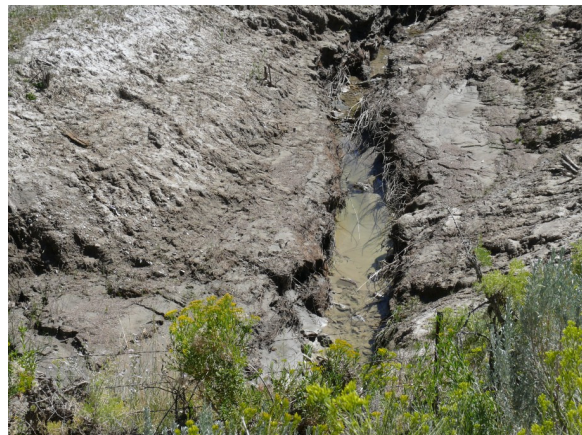
C. D.

Pictures C & D show where the wash crosses under the road and comes out south of Hunsaker's property.

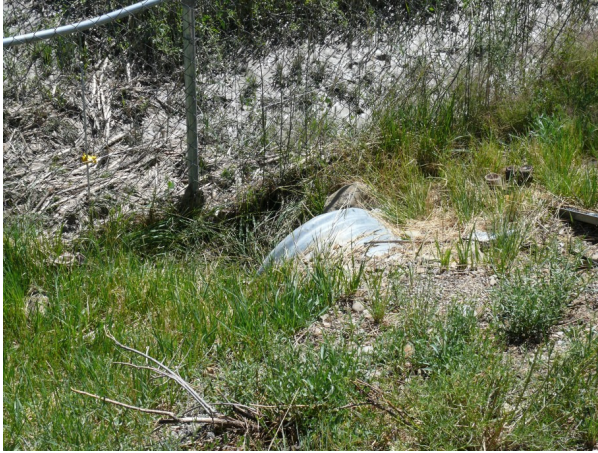
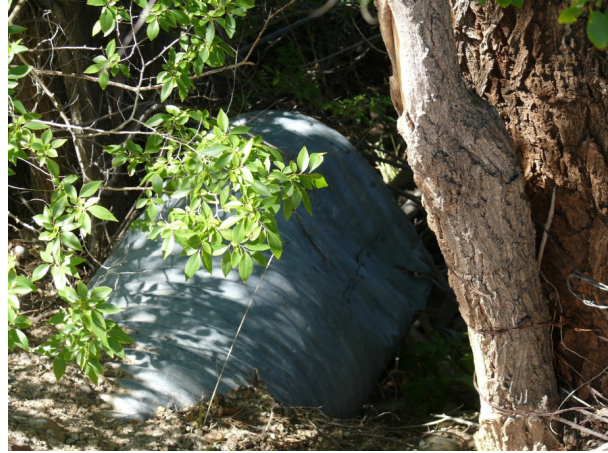
E. F.

Pictures E & F show where the wash crosses under the road and comes out north of Hunsaker's property.

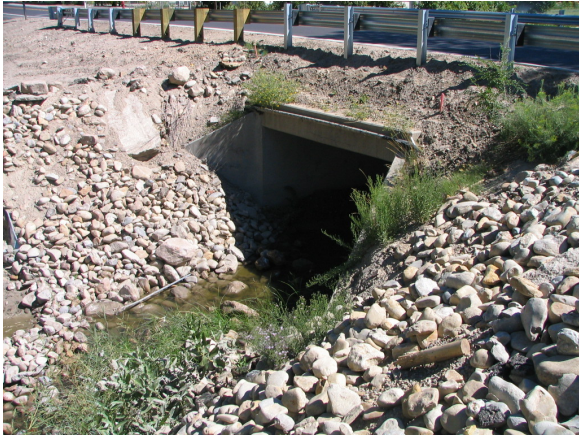
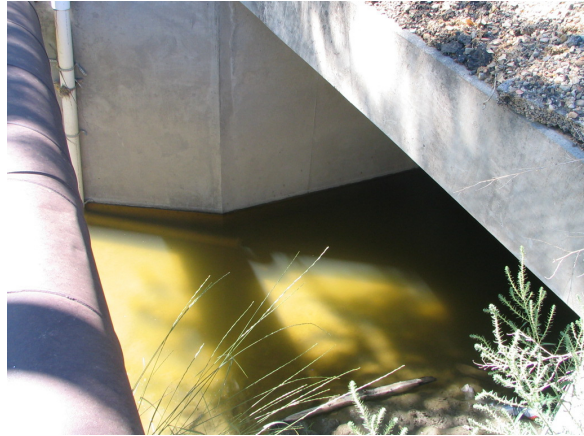
R. S.

Pictures R. & S. show where the drainage goes under the road and comes out heading west towards Price River on 4000 North.

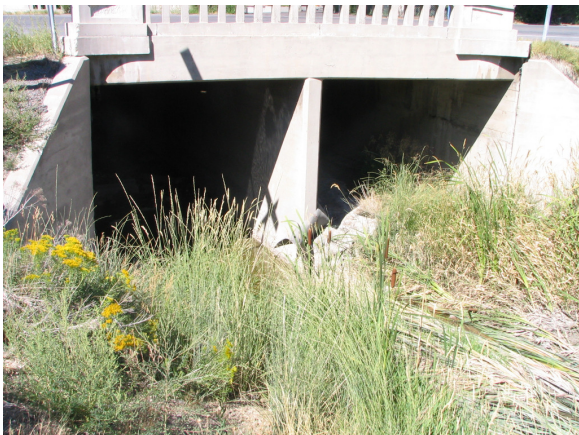
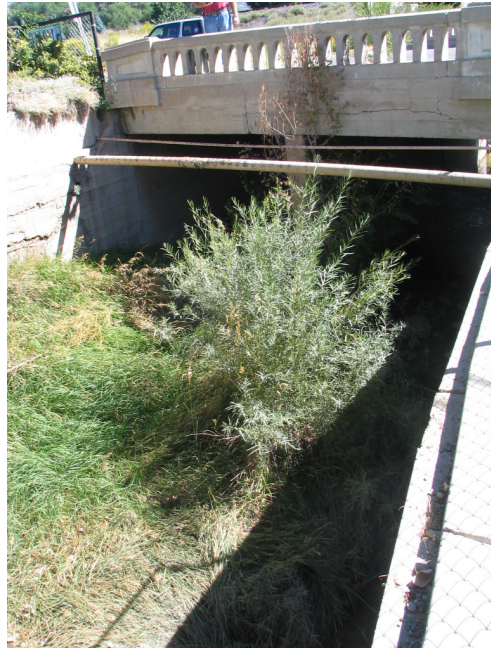
T. U.

Pictures T. & U. show where the drainage goes under Spring Glen Road and comes out heading west towards Price River.

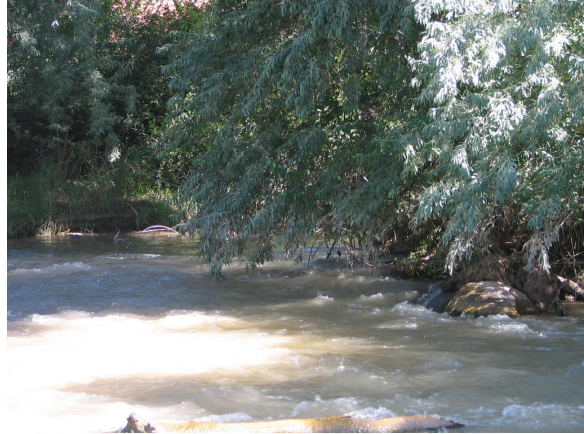
V. W.

Pictures V. & W. show where the drainage runs into Price River by Simm's property.

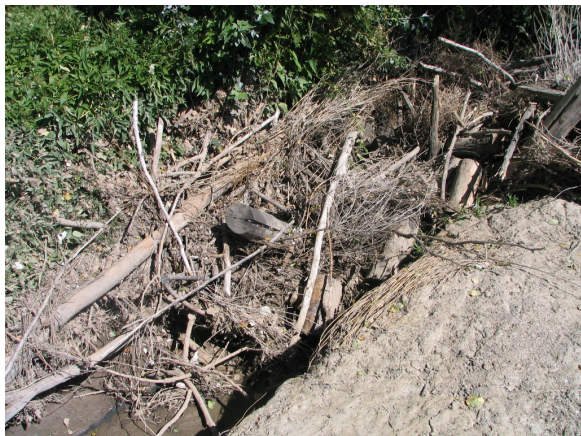
A.

Picture A shows where the drainage runs along the southeast side of the pasture heading towards the railroad tracks.

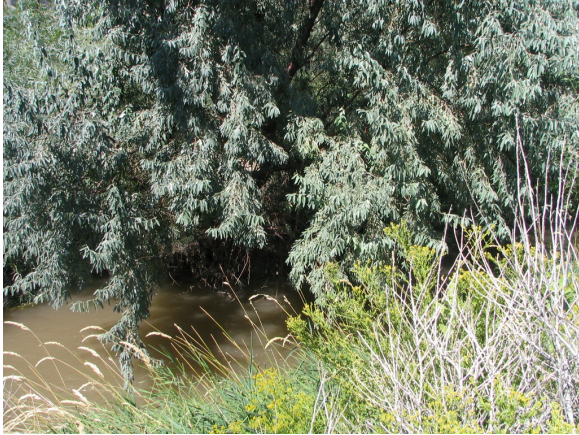
B.

Picture B shows where the drainage enters the canal south of the pasture. The drainage runs parallel with the railroad tracks until it goes into the canal.

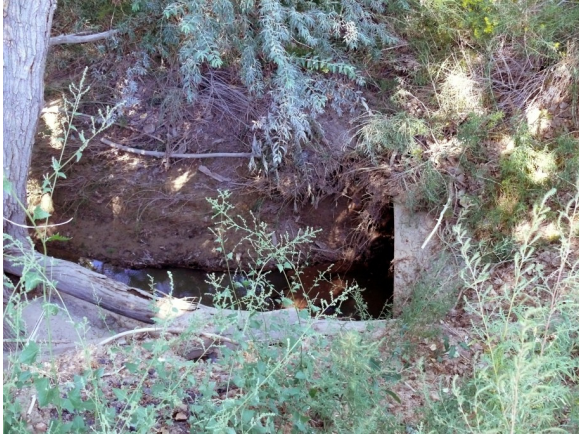
A.

Picture A shows the culvert that goes underneath the canal.

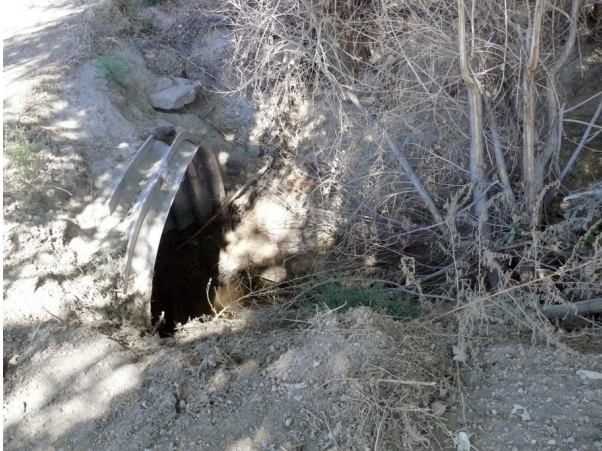
B.

Picture B shows the east side of the culvert going underneath Mountain States Road.

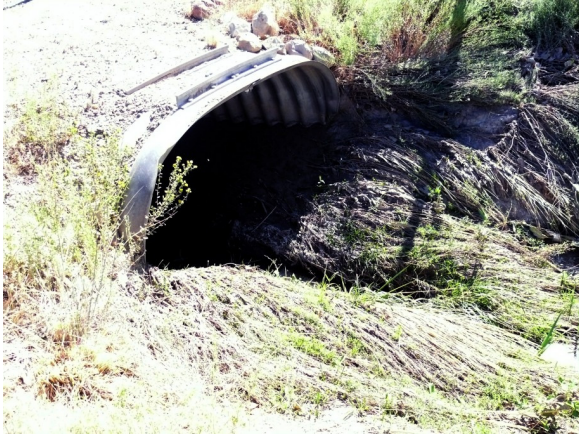
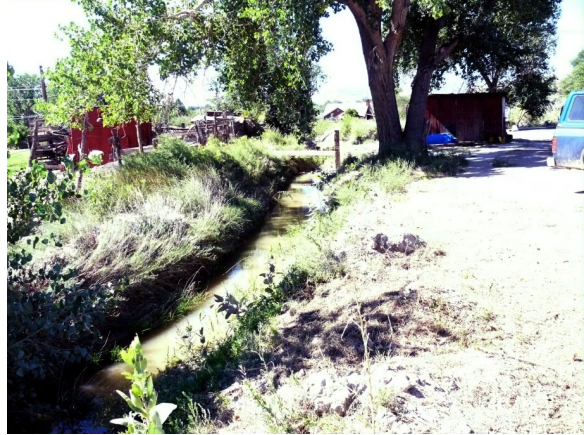
Picture C shows the west side of the culvert. Picture D shows the view looking west down the drainage towards the railroad tracks.

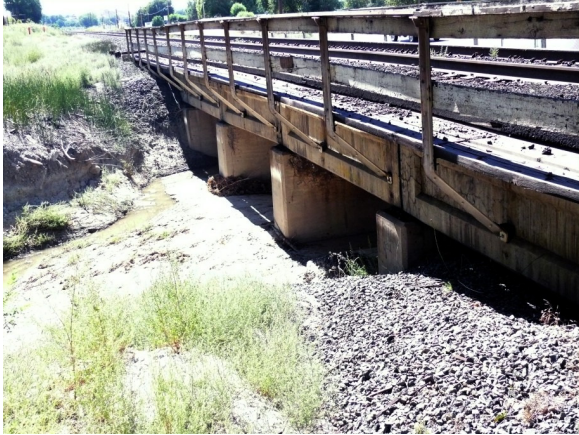
F.

Picture F shows the east side of the railroad crossing.

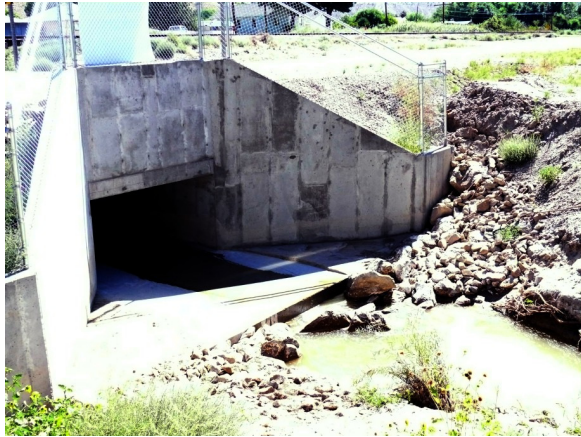
I.

Picture I shows the west side of the culvert going under Carbonville Road. There is water in this drainage.

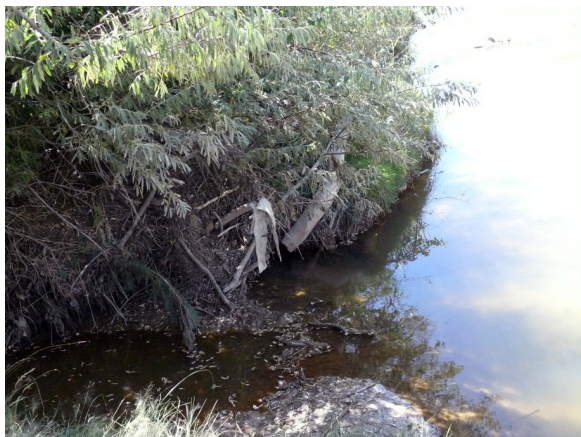
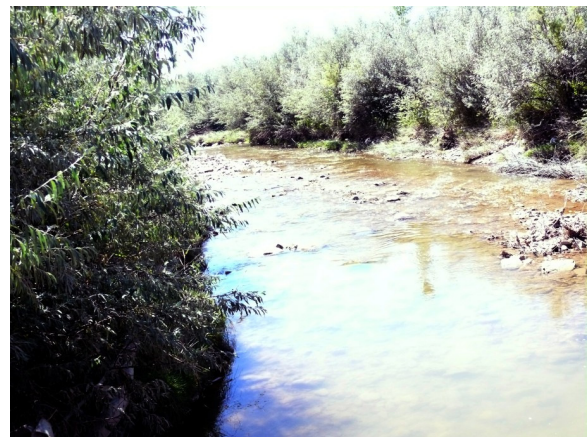
Picture M is of the confluence. Picture N is looking down Price River to the south from the same location.

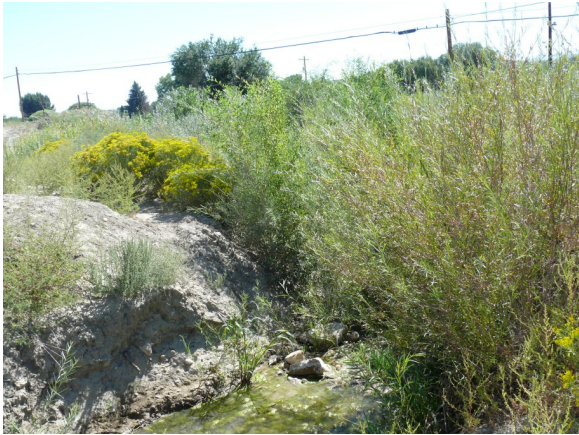
B.

Picture B is at the bend looking south along the drainage.

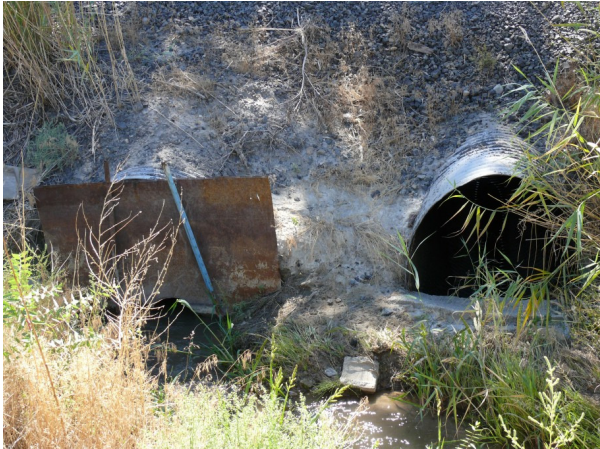
C.

Picture C is the east side of the railroad tracks. As you can see, one of the culverts is throttled down for irrigation usage. The overflow has to go through the culvert on the right.

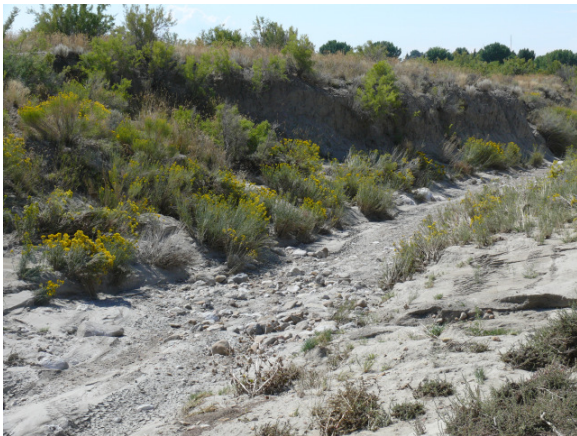
A.

Picture A shows the middle of the wash.

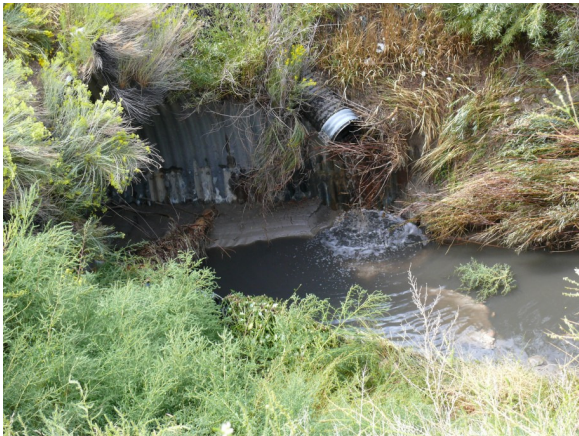
K.

Picture K shows where the drainage crosses Main Street by Smith's.

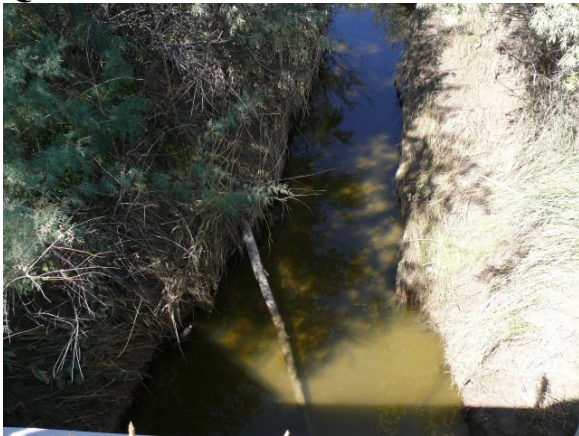
Q.

underneath HWY 6

Picture Q shows where the drainage enters

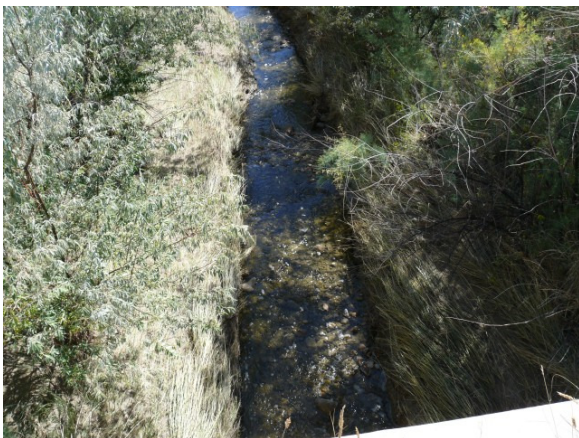
R.

underneath HWY 6.

Picture R shows where the drainage exits from

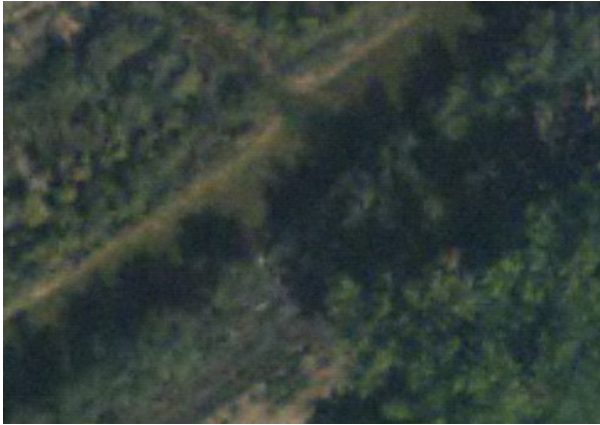
S.

S is an aerial photo of the confluence.

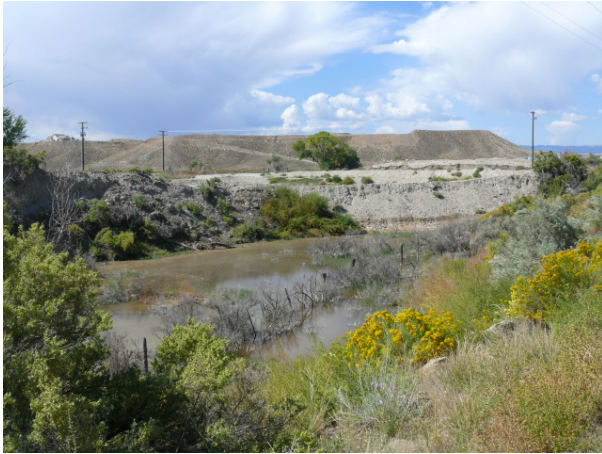
D.

Cardinal Wash above the flumes.

Picture D shows irrigation ponds leaching into

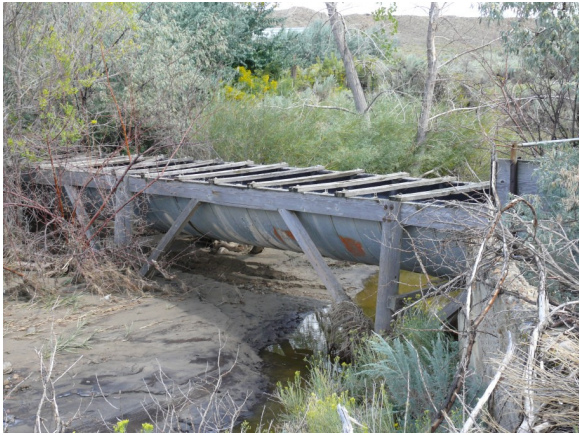
E.

Canal Flume south of Airport Road

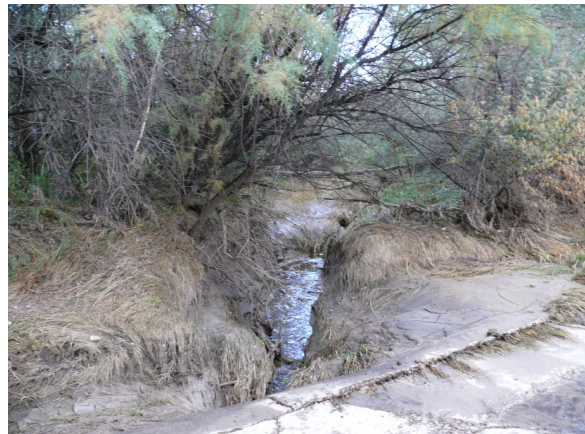
F. G.

Pictures F & G show the Bawdenville drainage crossing. As you can see from the pictures, the high water mark exceeds the culverts capacity.

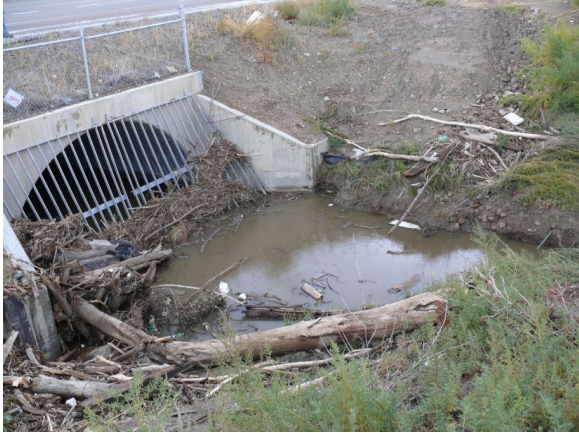
H.

Where drainage goes underneath HWY 6 heading towards Wellington from Price. Culvert is blocked with fence that catches debris and may cause flooding.

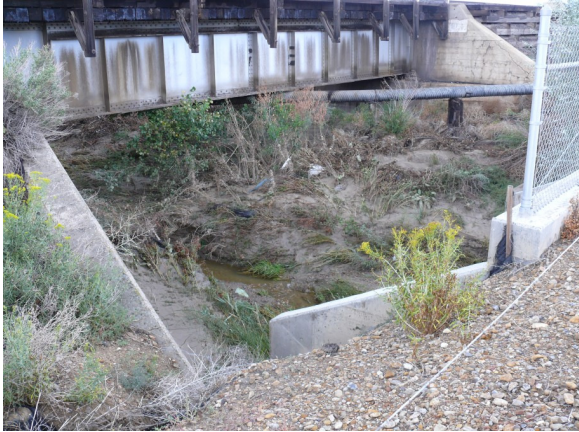
I.

Where drainage exits from underneath HWY 6 heading towards Wellington from Price. You can also see where drainage goes underneath the railroad tracks and towards the Price River.

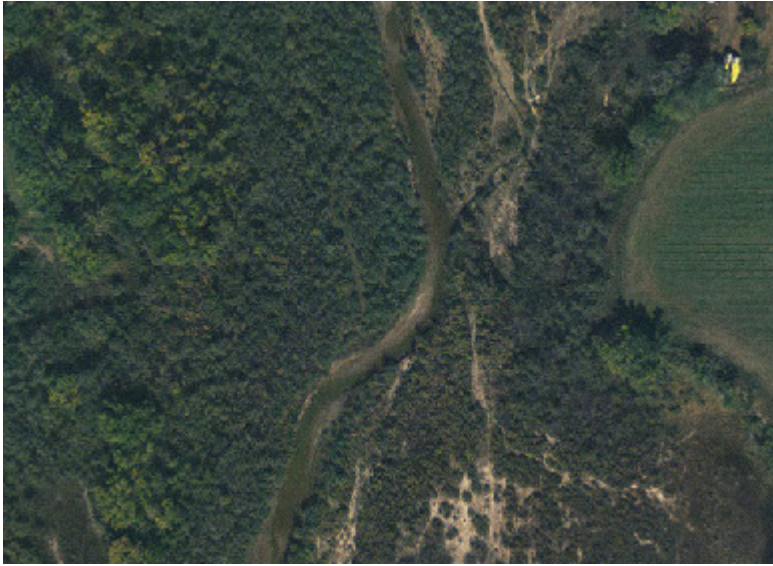
F.

confluence.

Picture F is an aerial photo of the

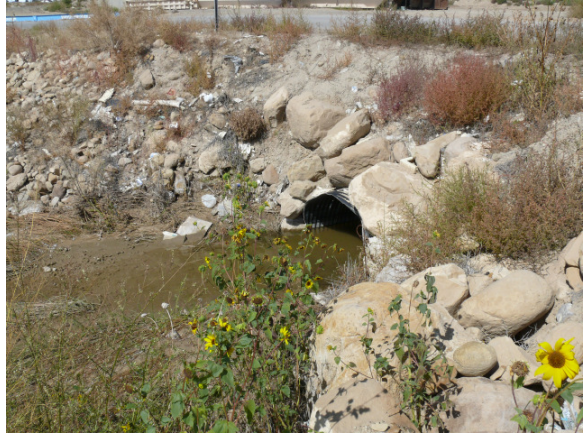
B.

Picture A is north of the road. Picture B is south of the road.

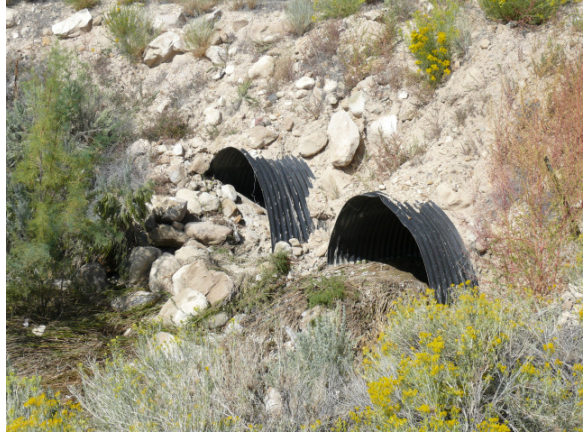
C. D.

Picture C is north of the road. Picture D is south of the road.

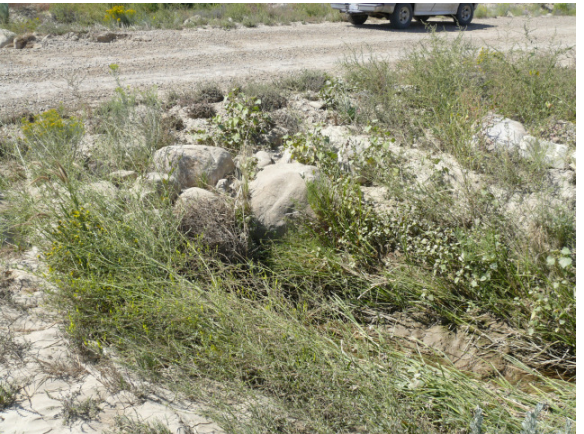
E. F.

Picture E is south of the road. Picture F is north of the road.

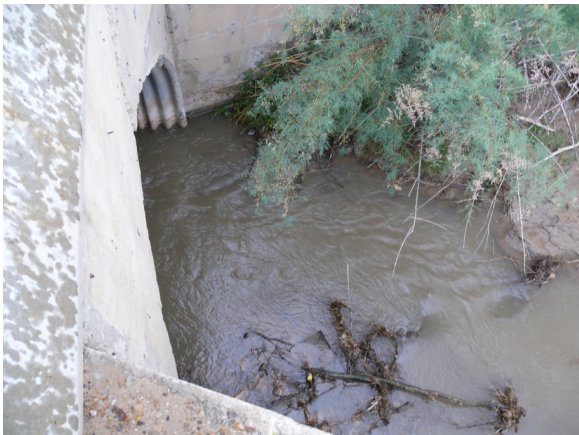
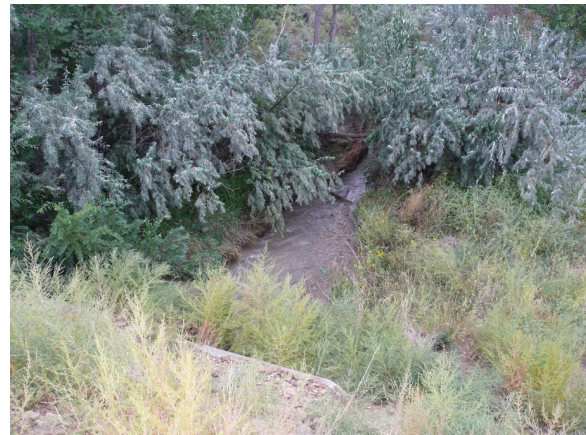
F. G.

Where drainage crosses underneath and comes out of Old Wellington Old

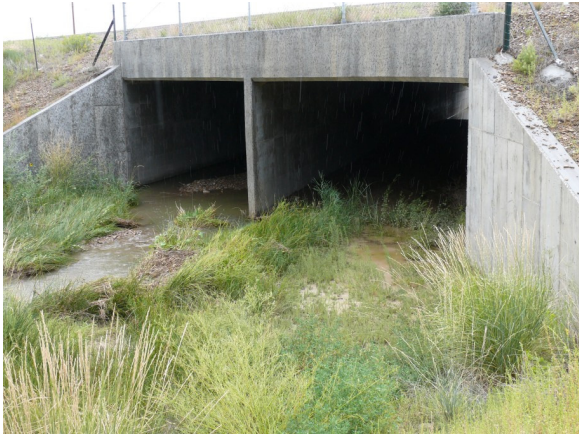
H.

Where drainage crosses underneath HWY 6 towards Wellington from Price by Mathis Property.

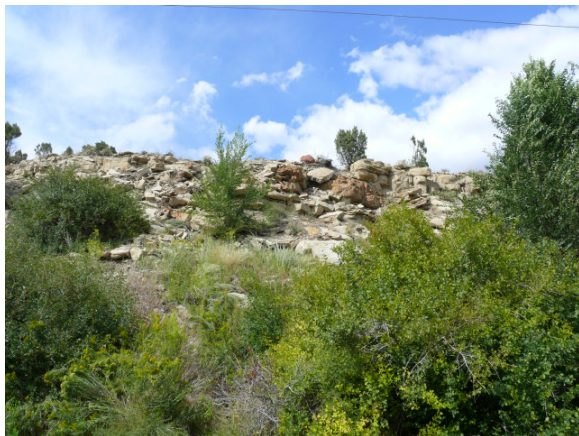
A.

Picture A shows former location of a catch basin.

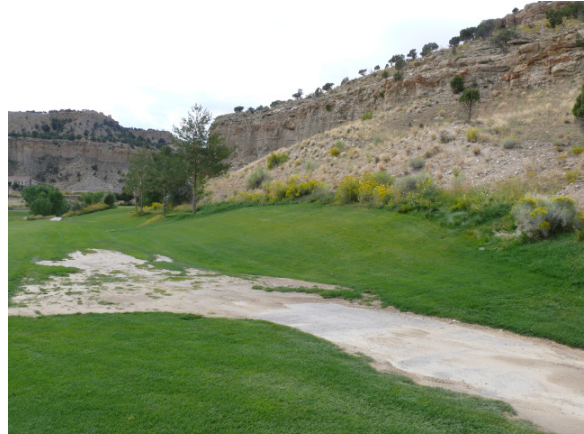
F.

Pictures E and F illustrate a natural drainage that runs a portion of the course, which needs to be addressed with, further flood control engineering.

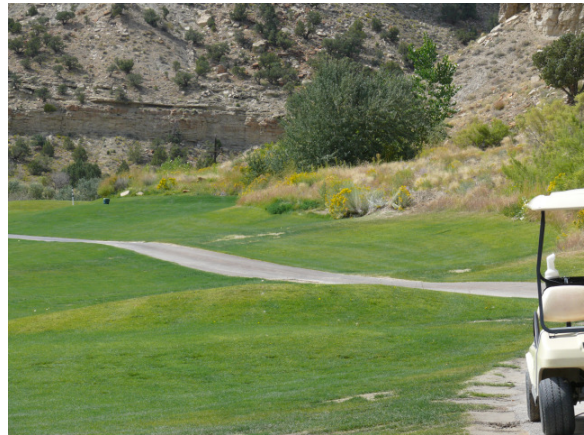
H.

Pictures G and H illustrate another drainage issue from the north side of a fairway. As you can see the topography lends itself to becoming flooded unless new ditches are created. Picture G shows a sand trap that is sometimes completely filled with water during heavy rains.

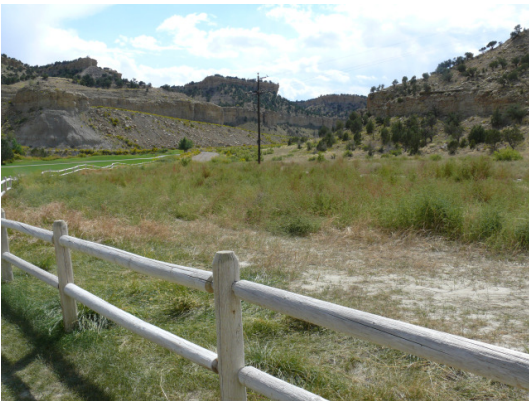
M.

This property parcel located west of the course lacks drainage ditches, which further cause flooding onto the course.

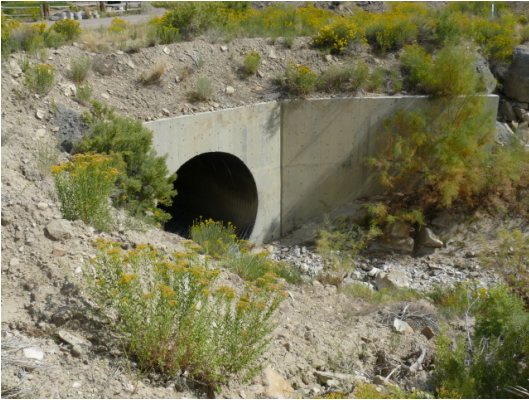
N.

Pictures N and O show the water course in Garley Wash from the west side of the course path (N) to the east (O). In picture O you can see the high water mark against the blue shale.
